GUIDELINES FOR RELIABLE EXTENSION OF TURBINE BLADE LIFE

by
Joseph Liburdi

James Wilson

Liburdi Engineering Limited

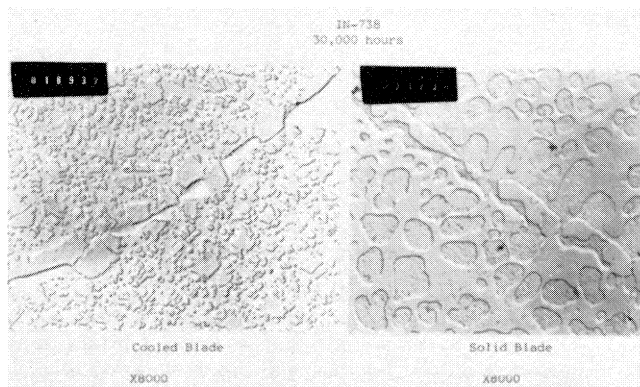
Figure 1. Electron Microscope Replicas of the Microstructures Exhibited by Two In738 Blades After Approximately 30,000 Hours of Service in Different Engines. The Structure on the Left, from a Cooled Blade, is Virtually Unaltered; Whereas, the Microstructure on the Right, from an Uncooled Blade Which Was Probably Exposed to Higher Metal Temperatures, Is Severely Overaged and Failed in Creep. Original Magnification $\times 8,000$.

approximately 30,000 hours of service, exhibited radically different results, depending on the engine and application [4]. In one case, as illustrated in Figure 1, the material was found to be stable and virtually unaltered; whereas, in a different application, the metal temperatures were probably higher, and the structure was severely overaged, resulting in premature creep failure.

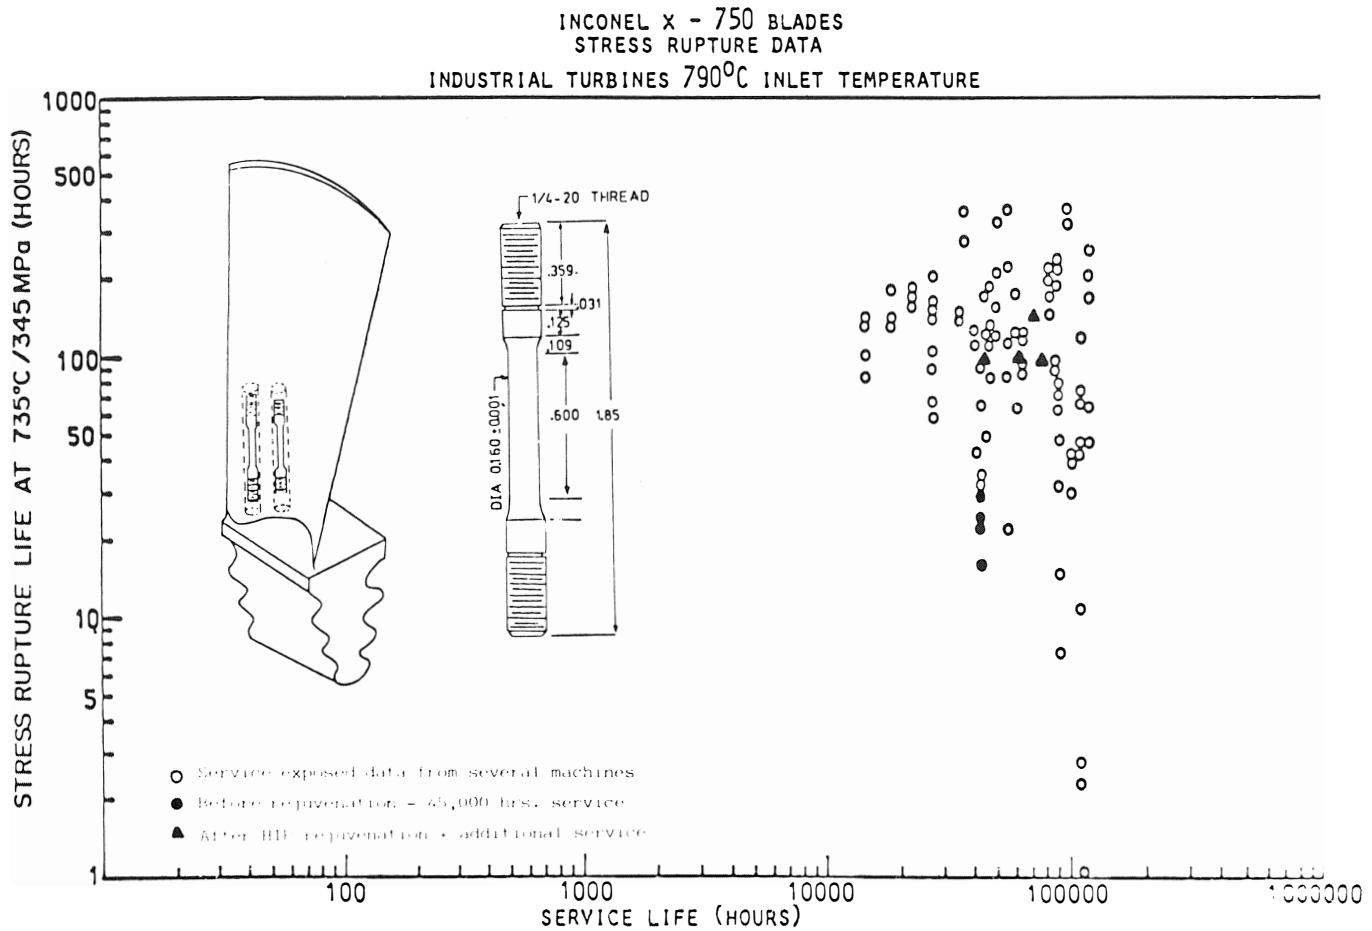
Figure 2. Life Trend Curve for Inconel X-750 Blades, Highlighting the Properties Exhibited by the W62 Row 3 Blades Before and After Rejuvenation.

The usefulness of a life trend plot can be best illustrated for the Inconel X-750 family of blades shown in Figure 2. These are uncooled, solid blades which are relatively easy to test.

The blades in question were removed from service in 1977, after approximately 45,000 hours of service. As indicated by the life trend curve, they had not yet reached their critical creep life, but because the properties fell below the specified minimum level, it was decided to rejuvenate the blades at this time. Subsequent investigations [3, 5] revealed that the premature decrease in life was probably due to a slightly weaker chemistry, and possibly original heat treatment. As noted in the original paper [1], conventional reheat treatment was not capable of fully restoring the properties, and superior results were obtained by adding hot isostatic pressing to the recovery cycle.

The results of stress rupture tests taken from the blade airfoil are illustrated in Figures 2 and 3. The graphs clearly illustrate that the mechanical properties have remained stable and the blades are suitable for continued service.

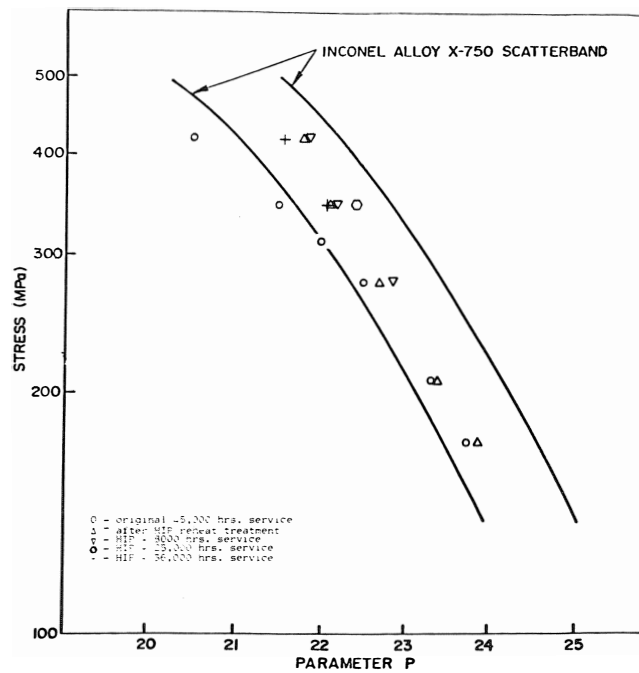
Figure 3. Larson-Miller Plot ($P = T \times 10^{-3} (20 + \log t)$, T in °K, t in Hours) Showing Original Service Exposed and HIP Processed Blade Stress Rupture Properties. After HIP the Blades Were Returned to Service and Monitored Periodically for Remaining Life.

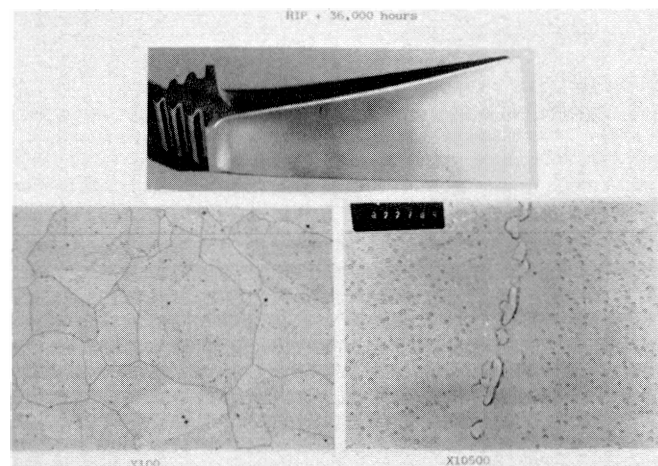
Figure 4. Photographs of the HIP Reheat Treated Inconel X-750 Blade After an Additional 36,000 Hours' Service. The Microstructure Is Virtually Unchanged, With Only Slight Grain Boundary Carbide Coarsening Evident.

The microstructural analysis shown in Figure 4 confirms that the alloy is behaving in a stable manner. The structure is typical of Inconel X-750 and shows little or no sign of overaging.

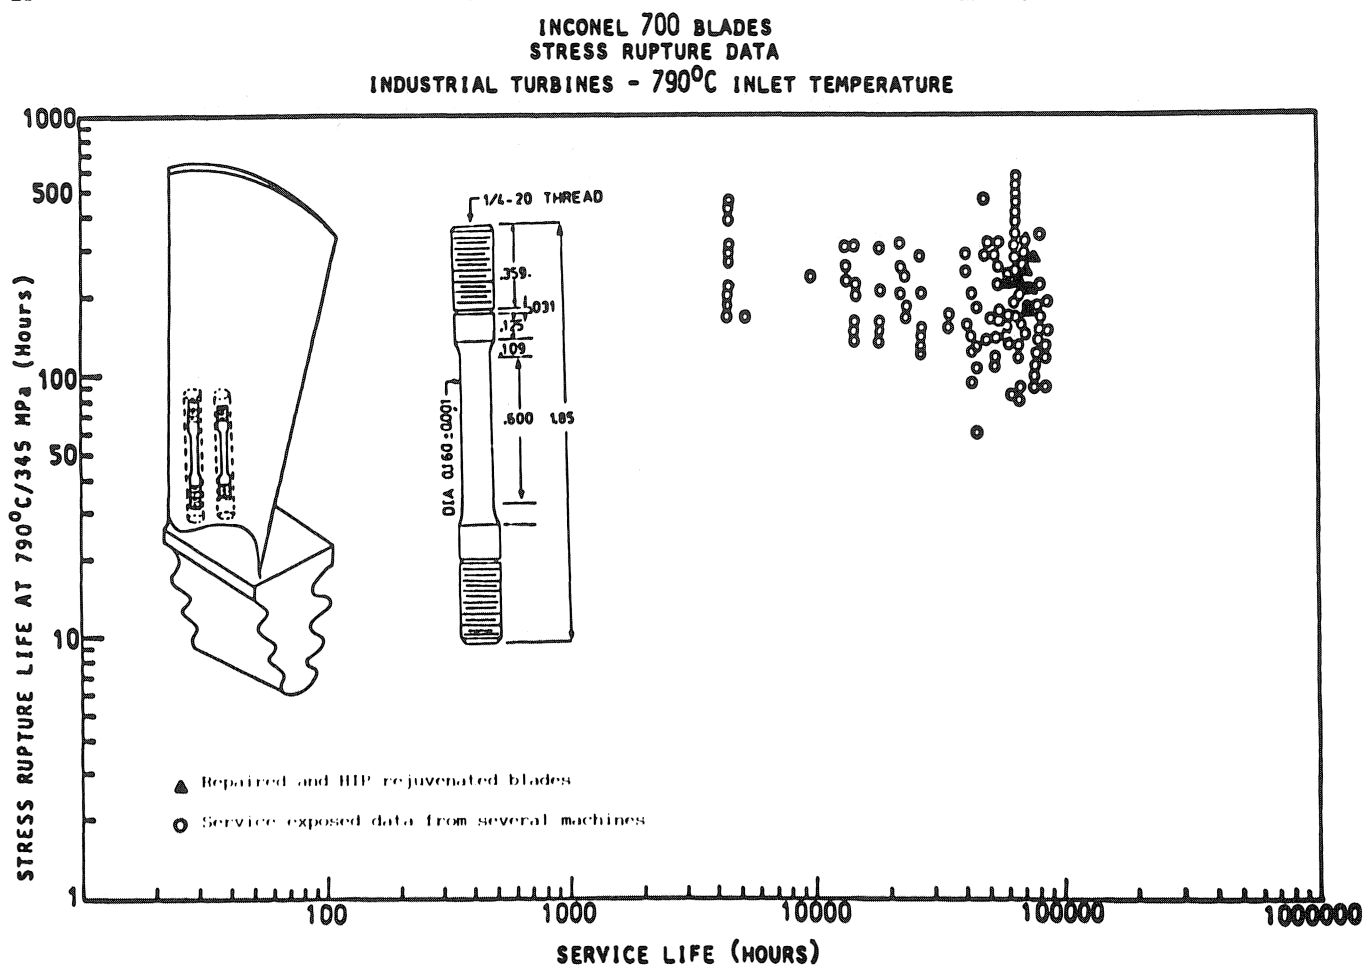
Figure 5. Life Trend Curve for Inconel 700 Blades, Showing the Effectiveness of the HIP Reheat Treatment Process on Repaired Blades.

In contrast, Inconel 700 blades from the same engines exhibit virtually no creep damage after approximately 100,000 hours of service (Figure 5). However, blades are often rejected because of foreign object damage, tip rubs or hot corrosion. In the past, these damaged blades could not be weld repaired or coated because they did not respond well to reheat treatment [6].

The stress rupture results after HIP rejuvenation, shown in Figure 5, are consistent with new material properties, and the ductility was restored to the required levels. The microstructure illustrated in Figure 6 is typical of new Inconel 700, with no detrimental acicular phases evident.

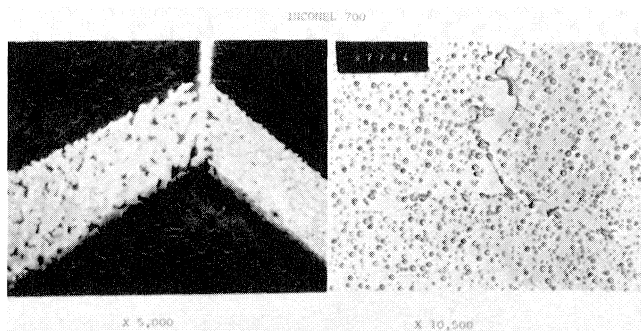
Figure 6. Photographs Illustrating the Structure of the Inconel 700 Blades After HIP Reheat Treatment. The Photograph on the Left Shows the Grain Boundary Carbide Network, While the Replica on the Right Shows the Strengthening Gamma Prime Particles.

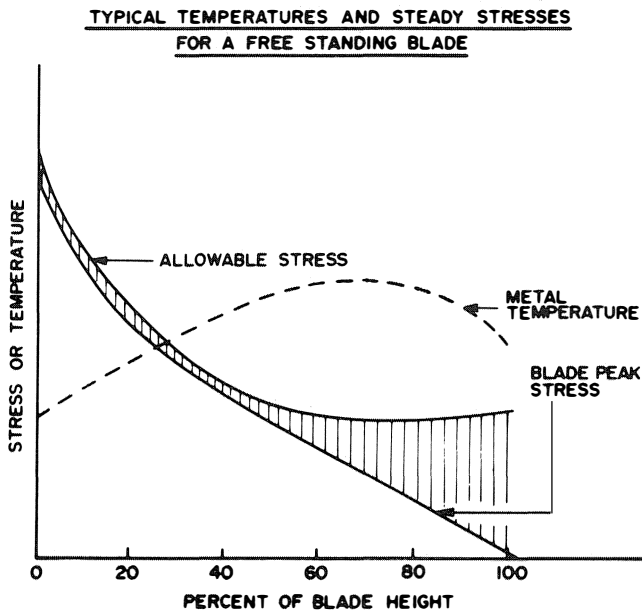
Figure 7. Diagram Illustrating the Net Section Stress Profile Along the Airfoil of a Free Standing (Unshrouded) Blade. The Band or Spread Between the Allowable and the Actual Blade Stress Determines the Average Strength Margin Available at Various Heights.

As indicated previously, the majority of the repairs performed to date have been accomplished using weaker weld filler materials such as Inconel 625 and, therefore, limited to the lower stressed portions of the airfoil. An analysis of a typical stress pattern for a free-standing blade, as shown in Figure 7, indicates that the margin of allowable stress over actual net section stress is greatest at the tip. This feature permits the use of lower strength welding materials close to the blade tip and accounts for the relative success enjoyed by such repairs. For example, Figure 8 shows a typical tip repair on an Inconel 700 blade using Inconel 625 weld metal.

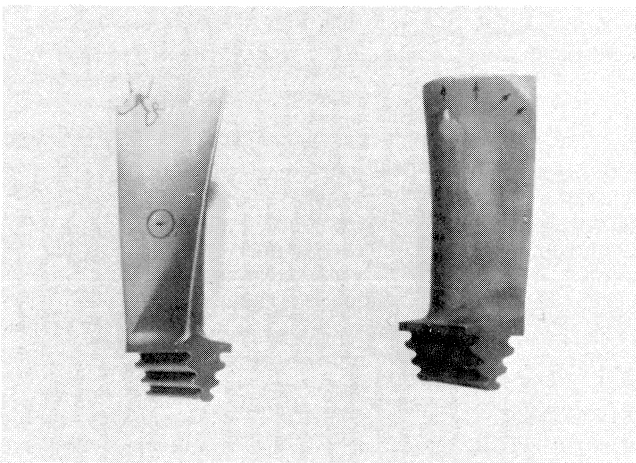
Figure 8. Photographs of a Service Damaged Inconel 700 Turbine Blade Before and After Weld Repair. Inconel 625 Filler Metal Was Used for Repairs Close to the Blade Tip Where the Stresses Are Low. Note That the Trailing Edge Repair Is Opened to the Tip to Minimize the Effect of Thermal Strains Resulting from the Different Coefficients of Expansion.

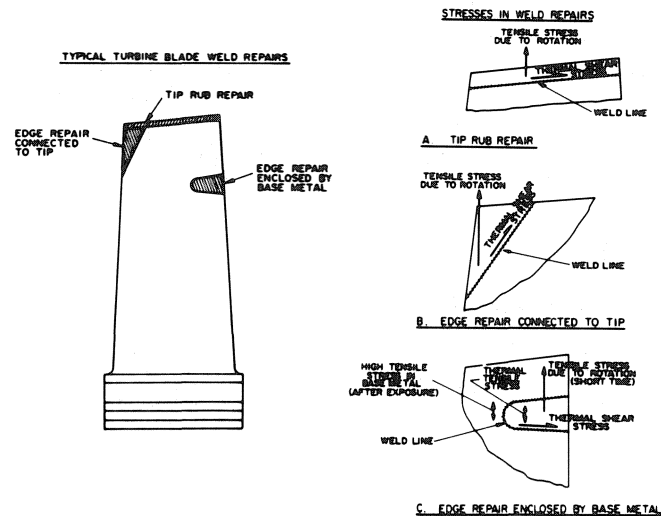
Figure 9. Diagrams Illustrating the Geometry of Typical Airfoil Weld Repairs, Along With a Summary of the Principal Stresses Due to Centrifugal Loading and Thermal Strains. In the Case of the Enclosed Notch, Differences in Coefficient of Expansion Will Result in Additive Tensile Stresses at the Tip of the Notch. Also, With Time, the Weaker Filler Metal Will Creep or Relax and Lose Its Load Carrying Ability.

In addition to the overall stress distribution, one must also consider the stress patterns associated with the various geometries or weld preparations used. The diagrams shown in Figure 9 illustrate the principal stresses along the weld interface arising from both centrifugal loading and differences in thermal expansion characteristics. The analysis indicates that, for tip- and edge-connected welds, the thermal shear stresses can be accommodated along the weld interface. However, care must be exercised when the weld repair geometry approximates a notch in the edge of the airfoil.

The notch repair can cause local high stresses due to material property differences between the weld and base metals. For instance, if the weld metal has a lower coefficient of thermal expansion than the base metal, the weld will be loaded in tension when the blade temperature rises during operation. Also, as the weld metal generally will have lower creep strength than the base metal, it will relax in service, and most of the load on the section will be transferred to the base material. The net effect can be that the weld metal carries almost no load and the repaired notch acts as a stress concentration.

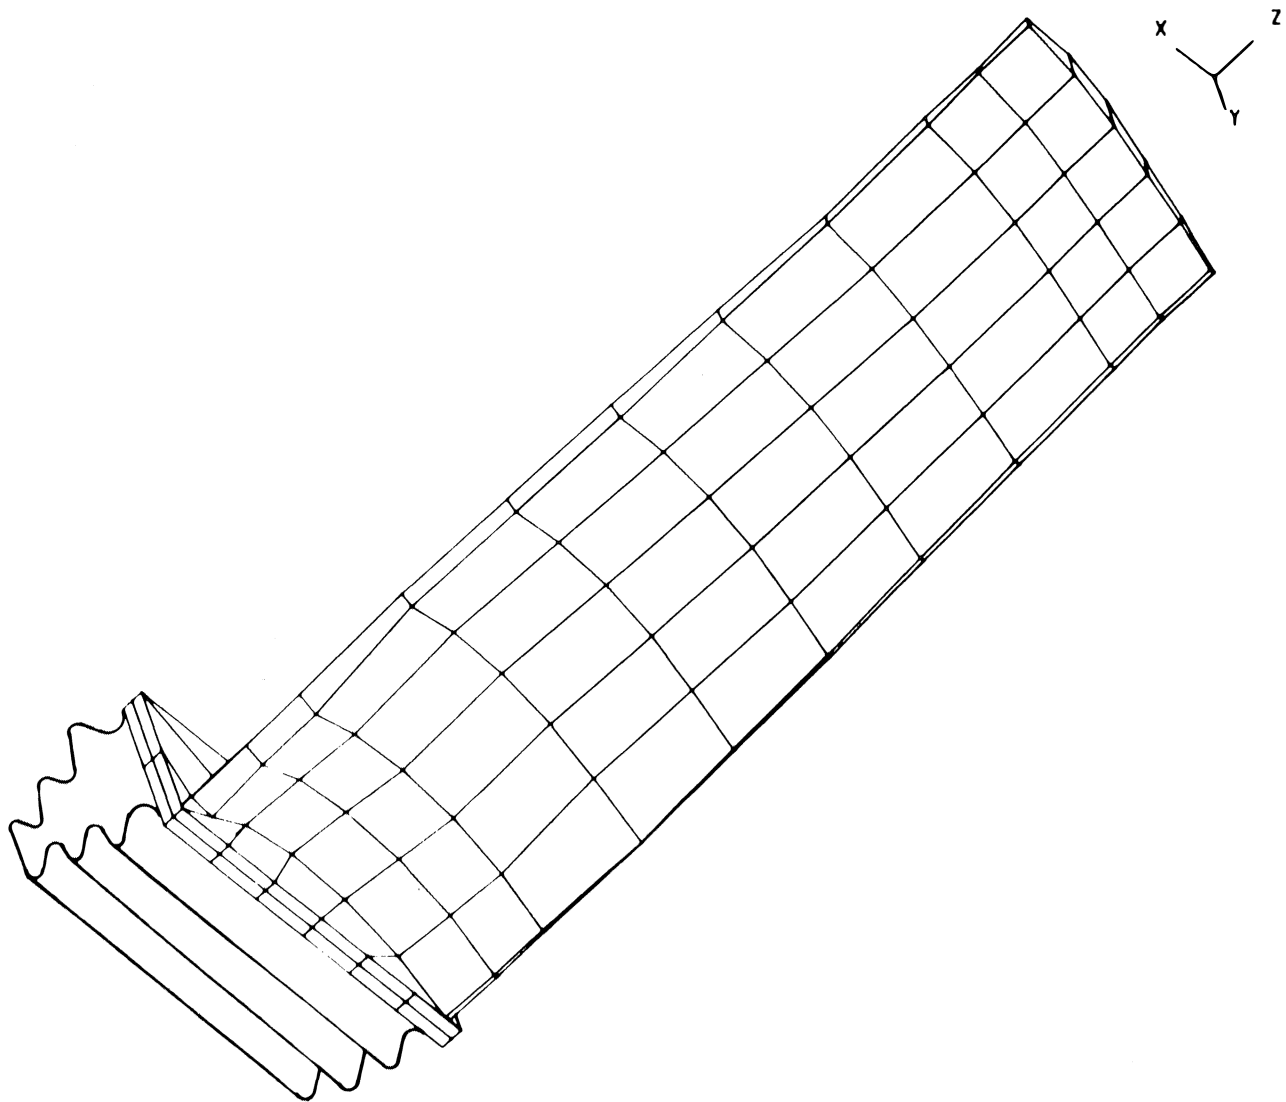
TURBINE BLADE 3-D MODEL WITH CENTRIFUGAL LOAD - 5000 RPM

Figure 10. Computer Plot of a Finite Element Mesh of a Free Standing Turbine Blade (Frame 5, Second Stage Bucket). The Curved Surfaces of the Airfoil Are Accurately Modelled by the Use of the Quadratic Element Formulation. The Blade Root Was Drawn In for Clarity.

A finite element model of a Frame 5 second stage turbine blade is shown in Figure 10. Twenty-node quadratic brick elements were used to accurately model the curved surfaces of the airfoil. The blade model was subjected to centrifugal and thermal loads, and the displacements, strains and stresses were calculated using the finite element computer program ANSYS (7).

the row of elements at the tip of the airfoil, and a comparison was obtained between the stress in the original blade and that in the tip repaired blade. The results, presented in Table 1, indicate that although the life, based on creep rupture, is reduced in the weld repaired area of the blade, it still exceeds the required overall airfoil life, and, therefore, the repair is considered satisfactory.

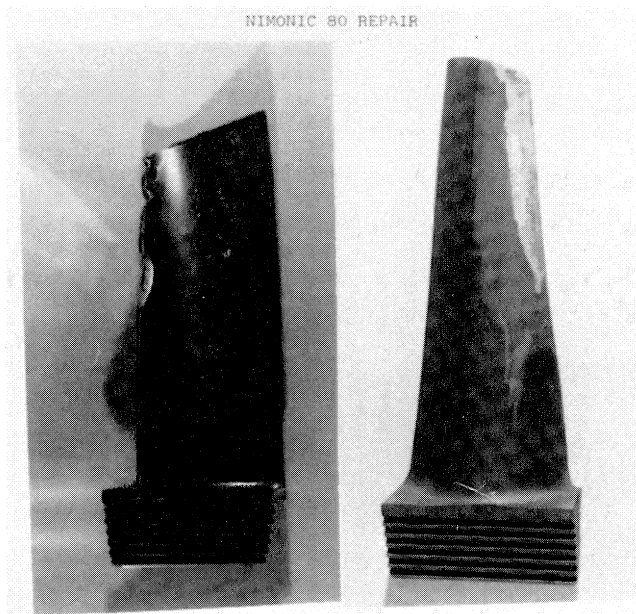
Figure 11. Photographs of a Nimonic 80 Service Damaged Blade Before and After High Strength Weld Repair. The Damage Extended into Highly Stressed Areas of the Leading Edge, and a Stronger Load Carrying Weld Material, Such as Inconel X-750, Was Required.

An example of the application of high strength welding is shown in Figure 11. These Nimonic 80 turbine blades had suffered extensive foreign object damage, which extended into the highly stressed areas of the leading edge and required the use of a matching filler metal. Inconel X-750 welding wire was chosen because of its availability and close match to the base material chemistry. The blades were HIP reheat treated after welding and tested for stress rupture properties. Favourable results, exceeding the new material requirements, were obtained from both the weld metal and the base material.

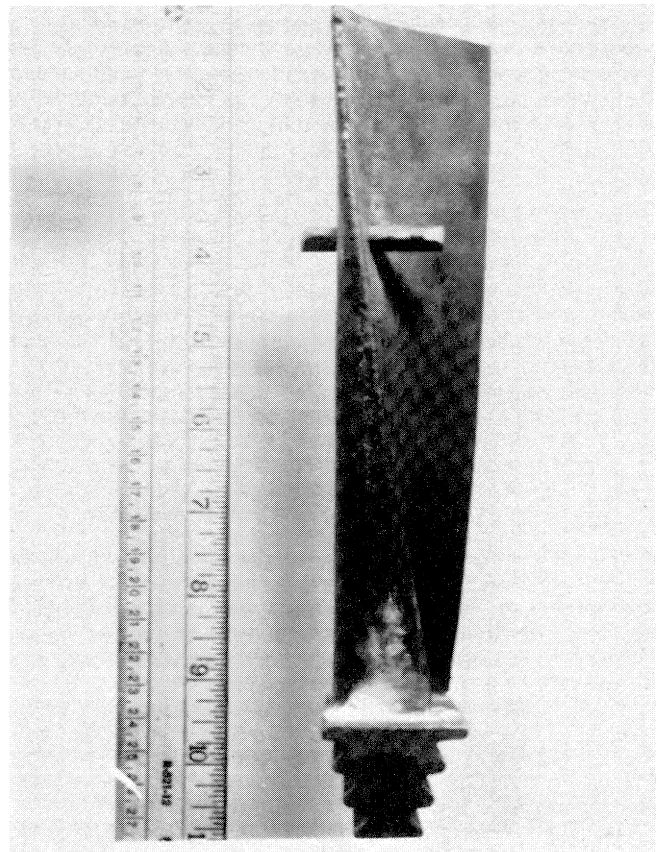
Figure 12. Photograph Showing an A286 Turbine Blade With Lashing Wire Still in Place. Lashing Wires Cause High Local Stresses in the Airfoil at the Hole, and Their Repair Requires Special Attention.

Another critical area which requires special attention is the repair of a blade lashing wire hole. Lashing wires are used on turbine stages to modify blade frequencies and to provide damping in order to avoid fatigue failures (Figure 12). The use of lashing wires creates a unique problem because the presence of the hole in the airfoil, combined with the centrifugal load of the wire, produces high local stresses. Premature creep rupture damage can occur near the hole, and corrosion and wear can make a repair necessary.

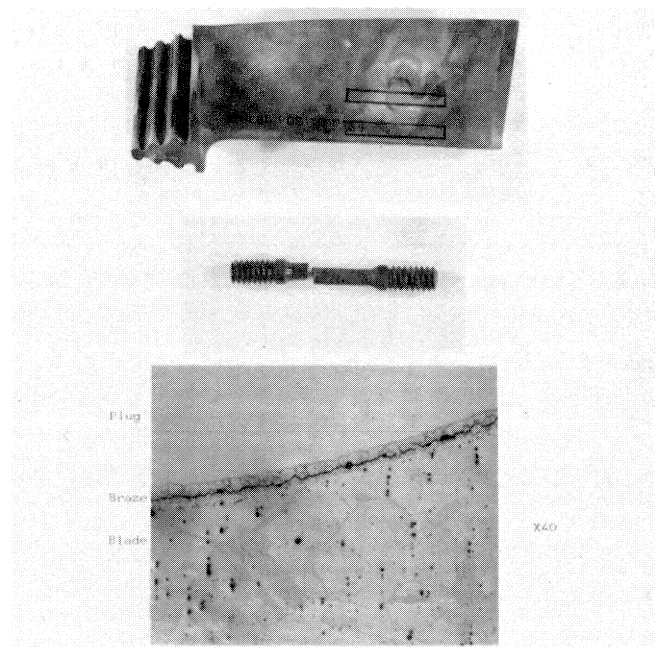
Figure 13. Photographs of the Failed Stress Rupture Sample Taken Through the Brazed Plug, Illustrating the Intergranular Failure Through the Braze Metal. The Braze Showed Much Lower Strength Than the Base Metal and Therefore Would Not Be Able to Adequately Transmit Load Across the Interface.

A common repair technique is to braze a bushing into the oversize hole. However, an evaluation of the strength of the braze repair, as shown in Figure 13, indicates that the interface does not have the necessary creep strength. Stress rupture samples taken through the brazed plug failed prematurely on loading along the weak braze interface.

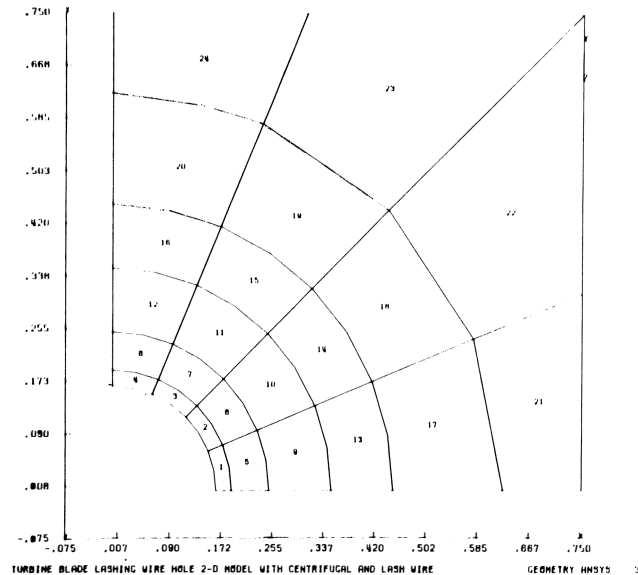
Figure 14. Computer Plot of a Turbine Blade Lashing Wire Hole, Modelled Using Finite Elements. The Model Is Constrained Along the Left and Lower Edges, and the Loads Are Applied in the Hole and Along the Upper Edge.

A two dimensional finite element model was therefore produced to evaluate the local stress field around the hole. Eight-node quadratic solid elements were used. The blade section was assumed to be of uniform thickness and to be symmetrical about the hole axes, so that only one quadrant was modelled (Figure 14). Uniform pressures were applied to simulate centrifugal loads due to the airfoil and the lashing wire. A uniform temperature was applied to all elements.

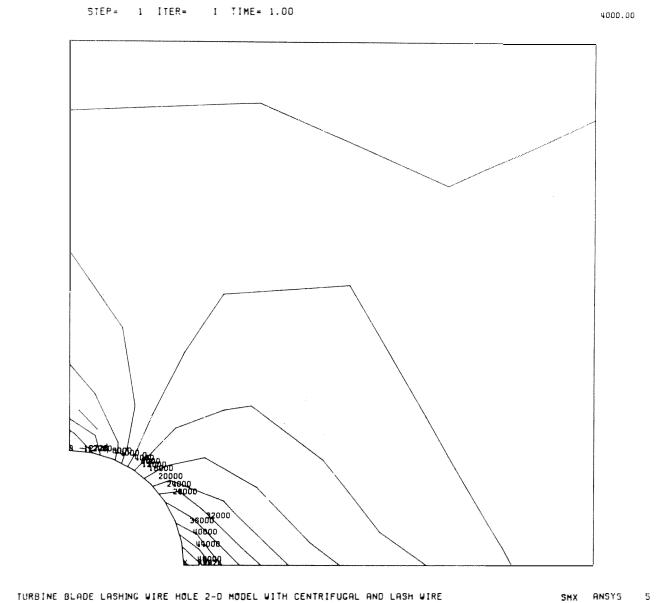
Figure 15. Computer Plot of Principal Stress at the Lashing Wire Hole With Uniform Material Properties.

A plot of equivalent stress in the structure is shown in Figure 15. The analysis indicates that the peak stress is at the edge of the hole and is five times higher than the average section stress. This implies that optimum material properties are required at the surface of the hole to withstand the high local stresses.

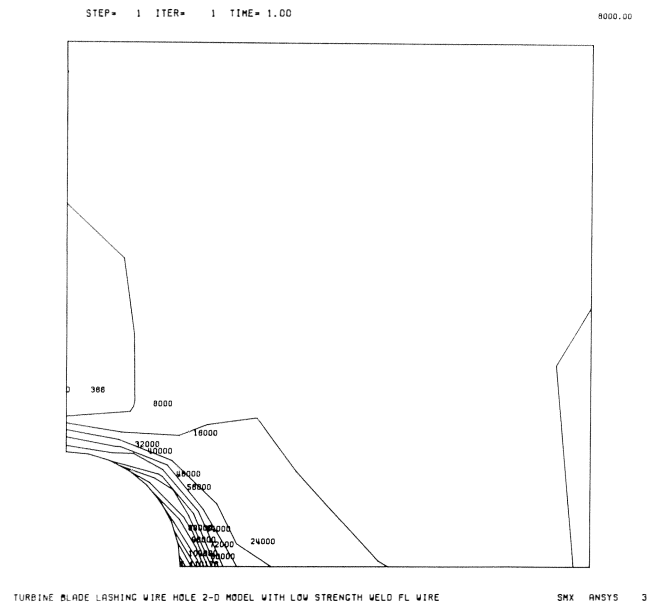
Figure 16. Computer Plot of Principal Stress at the Lashing Wire Hole Using Unmatched Weld Metal Properties Near the Hole. The Isostress Lines Show a Peak Stress of 110,000 psi in the Weld Metal at the Edge of the Hole.

Next, we considered the case of possible repairs to the hole using dissimilar weld metals or braze. The material properties of the row of elements closest to the hole were changed to model the effect of a mismatched weld metal repair. The results, illustrated in Figure 16, indicate that even higher local stresses are induced by this geometry. The reduction in creep rupture life caused by this type of repair was then calculated, and the results are summarized in Table 2. Obviously, this is a critical area of the blade, and any repair procedure should approach the strength of the original blade alloy.
